**Flood Control Project Maintenance
Levee Inspections**
LMA District Cover Sheet
Spring 2017 Levee Inspection Results

Sutter Maintenance Yard East Levee Sutter Bypass

Spring 2017 Levee Inspection Results

Waterway			Bank	Unit Miles
Unit No. 01 Sutter Bypass Levee			Left	21.68
	Spring (March - May)	Summer (June - August)	(September - November) Fall	Winter (December - February)
Unit Maintenance Rating (Fall Only)				
Date of Inspection	4/13/2017 - 4/13/2017			
DWR Inspector	Bob Duffey			
Accompanied By	Steve Beckley Sutter Maintenance Yard

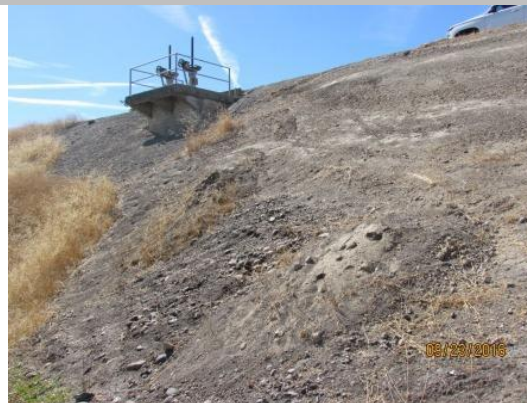
Photo 1 of 1 : SP_2017_ST0002_450_30_20170315_00008.jpg

LM Start	3.54	Rating **	M	Issue No.	30
LM End	3.54	Issue Type +	Ma	Location *	LS
Category	Earthen Levee			GPS Latitude/Longitude	
				Start	End
Item	Animal Control			39.120417 °	39.120417 °
				-121.779863 °	-121.779863 °
DWR ID	DWR_ST0002_01_f_2015_30				
Comment Code					
A3 : No rodents visible, but rodent burrows visible; need to backfill and compact or grout burrows.					
Inspector Comment

View of the rodent holes along the landside slope.

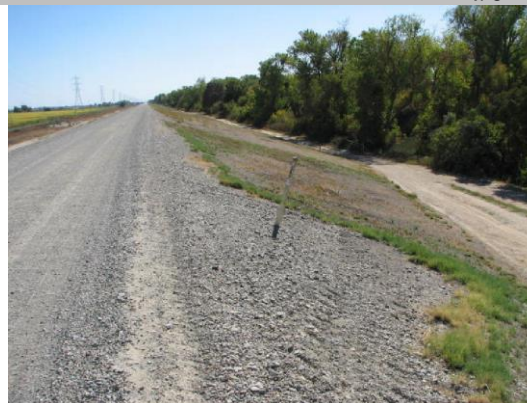
Photo 1 of 3 : UCIP_SP_2017_51582_65213.jpg

Gasline marker on WS shoulder.

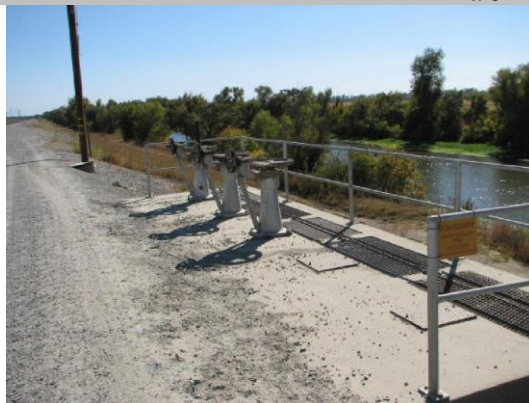
Photo 1 of 3 : UCIP_SP_2017_51595_65251.jpg

Slide gates on WS shoulder

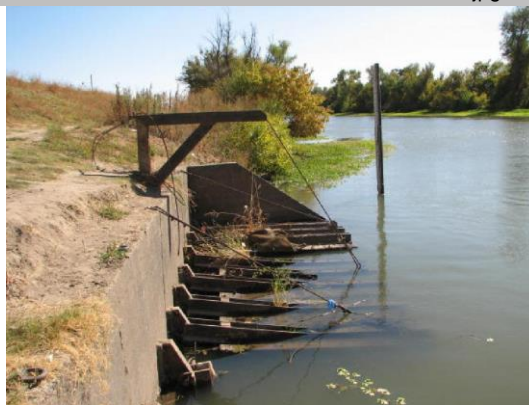
Photo 2 of 3 : UCIP_SP_2017_51595_65250.jpg

Flap gates on WS toe.

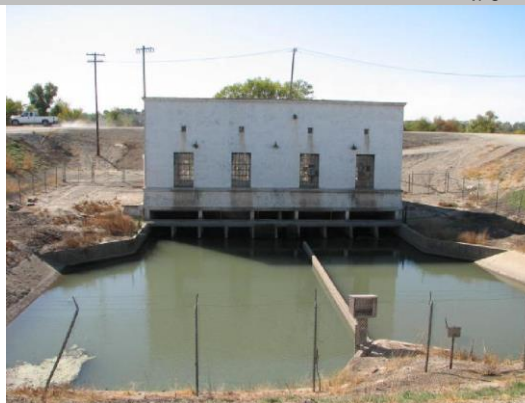
Photo 3 of 3 : UCIP_SP_2017_51596_65252.jpg

Item	DWR UCIP LMA Responsibility			39.025683 °		39.025683 °
				-121.726886 °		-121.726886 °
DWR ID						
Comment Code						
Inspector Comment						
FS_ID:51596 DS_ID:16906 EP_NO: N/A Repair Type: Non-Urgent Crossing Status: Found UCIP Comments: 4/11/2017 Abandoned.10/10/2016 Crossing appears to be in good condition. (DWR Sutter Yard - afreitag)4/18/2016 Abandoned crossing but no noticeable issues seen with it.5/7/2015 Abandoned crossing but no noticeable issues to report.11/12/2014 Same as last inspection.5/13/2014 Same as last inspection.10/30/2013 Same as last inspection.5/22/2013 Same as last inspection.10/8/2012 Determine type of abandonment. FIELD_STRUCT_DESC: *ABANDONED* [Pumping Plant No. 2] 2 of 5. 4-foot by 6-foot concrete drainage culvert through the levee, 31.5 feet below the crown. Wood flap gate and concrete headwall on the waterside (WS) end. Wooden steps on the landside (LS) slope. Concrete steps on the WS end. [Additional Reference(s): DWR Levee Log, 2005. USACE Sacramento O&M Manual 315, May 1953 (Station 582+19)] FS Date: 4/13/2017 2:17:39 PM

Pumping plant on LS toe.

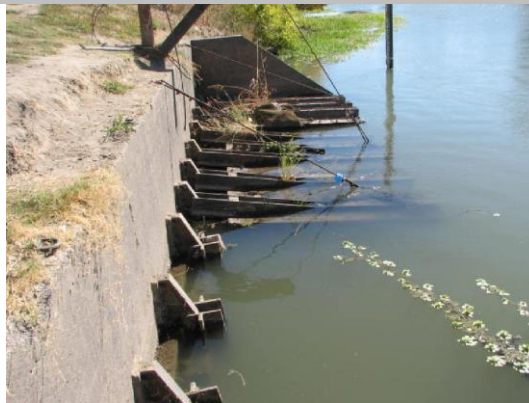
Photo 2 of 3 : UCIP_SP_2017_51597_65256.jpg

Flap gates on WS toe.

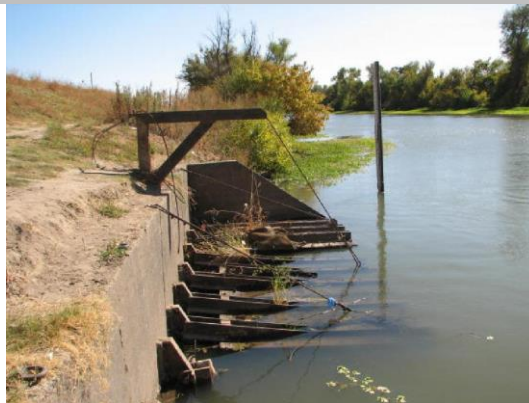
Photo 2 of 3 : UCIP_SP_2017_51598_65259.jpg

Flap gates on WS toe.

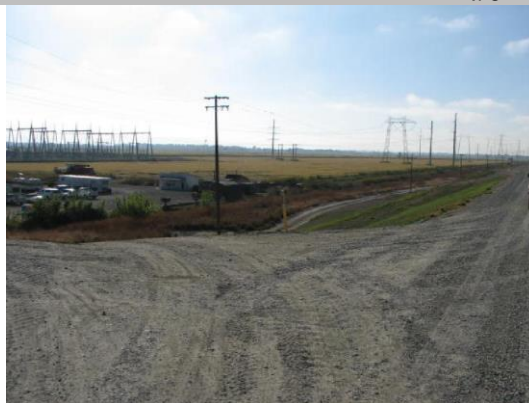
Photo 1 of 3 : UCIP_SP_2017_51601_65266.jpg

Gasline marker on LS shoulder.

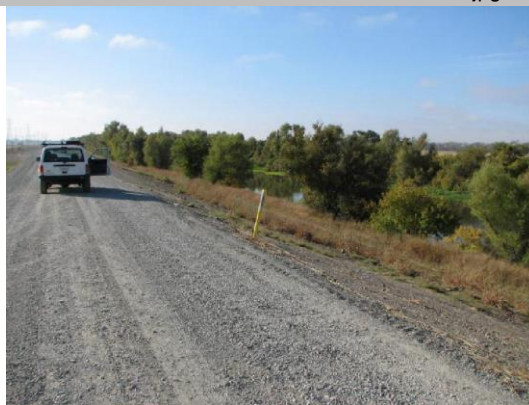
Photo 2 of 3 : UCIP_SP_2017_51601_65265.jpg

Gasline marker on WS shoulder.

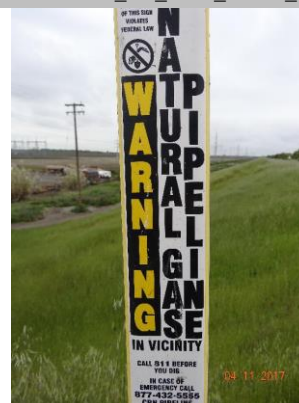
Photo 3 of 3 : UCIP_SP_2017_51601_76971.jpg

Close up of marker

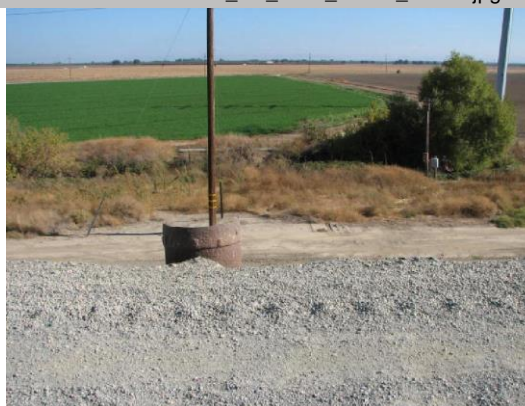
Photo 2 of 3 : UCIP_SP_2017_51605_65313.jpg

Steel riser on LS shoulder.

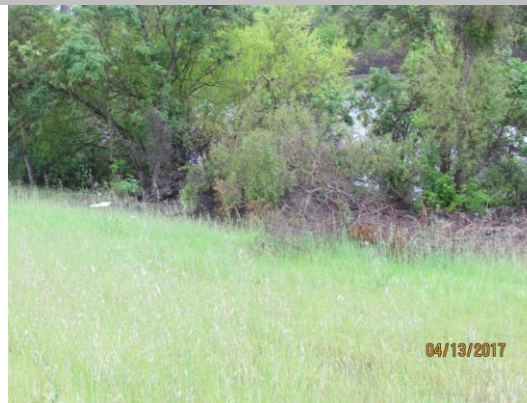
Photo 1 of 1 : SP_2017_ST0002_450_46_20170413_00073.jpg

LM Start	15.24	Rating **	M	Issue No.	46
LM End	15.24	Issue Type +	En	Location *	WS
Category	Earthen Levee			GPS Latitude/Longitude	
				Start	End
Item	Encroachments			38.974510 °	38.974510 °
				-121.684290 °	-121.684290 °
DWR ID	DWR_ST0002_01_s_2017_46				
Comment Code					
TR : Tree or limb					
Inspector Comment					
Remove the tree from the waterside toe.

View of the tree at the waterside toe.

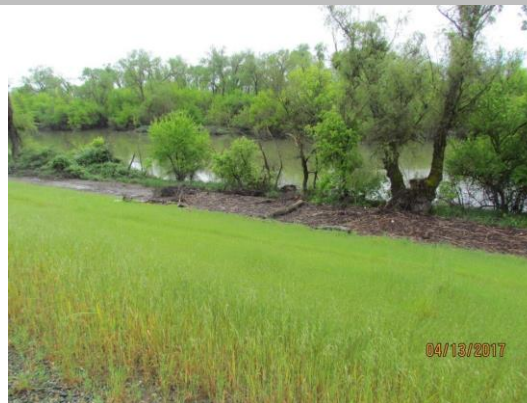
Photo 1 of 1 : SP_2017_ST0002_450_48_20170413_00075.jpg

LM Start	16.44	Rating **	M	Issue No.	48
LM End	16.44	Issue Type +	En	Location *	WS
Category	Earthen Levee			GPS Latitude/Longitude	
				Start	End
Item	Encroachments			38.962923 °	38.962923 °
				-121.667787 °	-121.667787 °
DWR ID	DWR_ST0002_01_s_2017_48				
Comment Code					
DE : Debris					
Inspector Comment					
Remove the debris from the waterside toe.

View of the debris at the waterside toe.

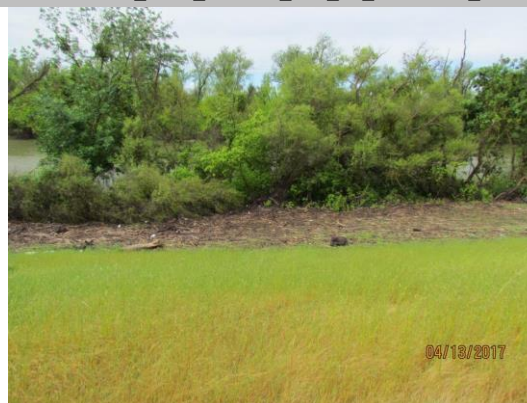
Photo 1 of 1 : SP_2017_ST0002_450_53_20170413_00079.jpg

LM Start	17.12	Rating **	M	Issue No.	53
LM End	17.12	Issue Type +	En	Location *	WS
Category	Earthen Levee		GPS Latitude/Longitude		
			Start	End	
Item	Encroachments		38.955352 °	38.955352 °	
			-121.659657 °	-121.659657 °	
DWR ID	DWR_ST0002_01_s _ 2017_53				
Comment Code					
DE : Debris					
Inspector Comment					
Remove the debris from the waterside toe.

View of the debris along the waterside toe.

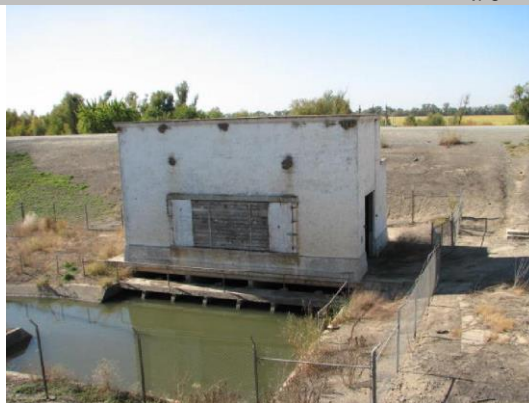
Photo 1 of 3 : UCIP_SP_2017_51609_65326.jpg

Pumphouse on LS toe.

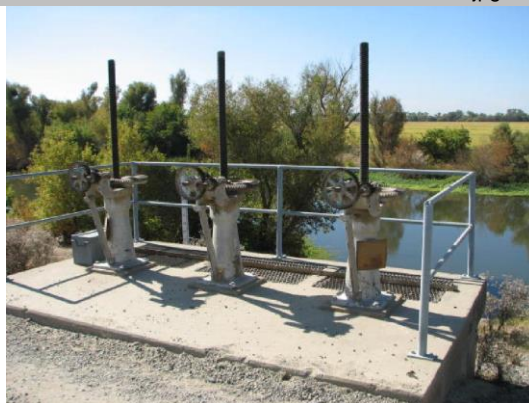
Photo 2 of 3 : UCIP_SP_2017_51609_65325.jpg

Slide gates on WS shoulder.

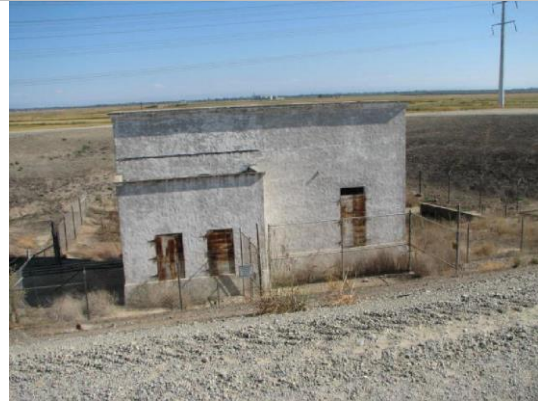
Photo 1 of 3 : UCIP_SP_2017_51610_65330.jpg

Pumphouse on LS toe.

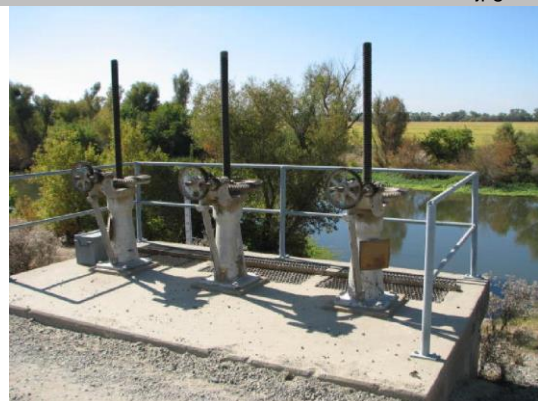
Photo 2 of 3 : UCIP_SP_2017_51610_65329.jpg

Slide gates on WS shoulder.

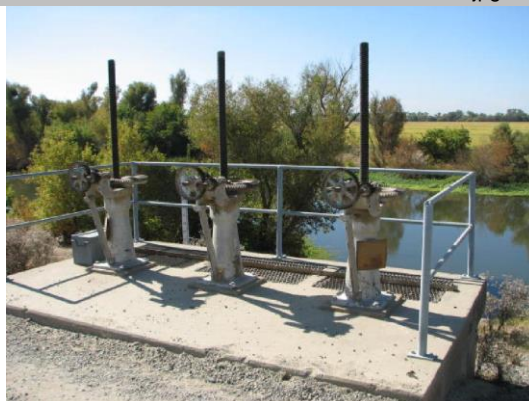
Photo 2 of 3 : UCIP_SP_2017_51611_65332.jpg

Slide gates on WS shoulder.

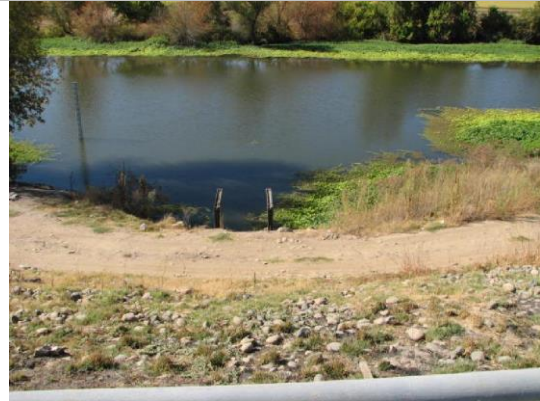
Photo 3 of 3 : UCIP_SP_2017_51611_65331.jpg

Item	DWR UCIP LMA Responsibility			38.932460 °	38.932460 °	
				-121.635150 °	-121.635150 °	
DWR ID						
Comment Code						
Inspector Comment						
FS_ID:51611 DS_ID:17028 EP_NO: N/A Repair Type: No Action Needed Crossing Status: Found UCIP Comments: 4/11/2017 Not Abandoned. Good Condition. (DWR Sutter Yard - A Freitag)10/10/2016 NOT ABANDONED. The old pumping plant was abandoned but the culverts are still used as a gravity drain to regulate the water level in the LS ditch.(DWR Sutter Yard - a Freitag)4/18/2016 Crossing is in good condition. The culvert is not abandoned and is used as gravity drain for the LS ditch into the bypass channel.5/7/2015 Concrete culvert is being used as a gravity drain for LS ditch.11/12/2014 Same as last inspection.5/14/2014 Same as last inspection.10/30/2013 Same as last inspection.5/23/2013 Concrete culvert is being used as gravity drain for LS ditch.10/9/2012 Need to determine type of abandonment for concrete culverts. FIELD_STRUCT_DESC: [Pumping Plant No. 1] 3 of 3. 4-foot by 6-foot concrete drainage culvert through the levee, 26 feet below the crown. Slide gates in a concrete well on the waterside (WS) shoulder. Wooden flap gates and concrete headwall on the WS end. Concrete steps and staff gage reading to 53 feet on the WS slope. [Additional Reference(s): DWR Levee Log, 2005. USACE Sacramento O&M Manual 315, May 1953 (Station 141+46)] FS Date: 4/13/2017 2:50:01 PM

Flap gate at WS toe.

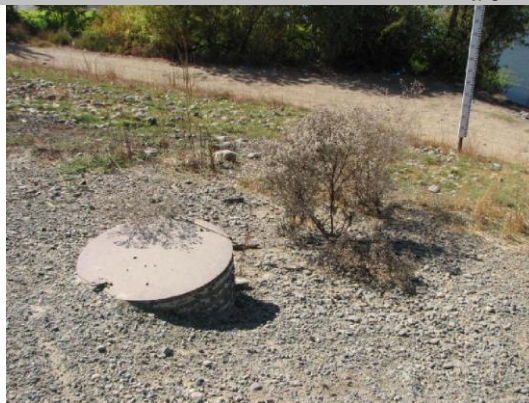
Photo 1 of 1 : UCIP_SP_2017_51612_65334.jpg

Comment Code					
Inspector Comment					
FS_ID:51612 DS_ID:16878 EP_NO: 3165 Repair Type: Non-Urgent Crossing Status: Found UCIP Comments: 4/11/2017 Abandoned. (DWR Sutter Yard-AFreitag)10/10/2016 Abandoned crossing. (DWR Suter Yard-afreitag)4/18/2015 Abandoned crossing. No noticeable issues to report.5/7/2015 Abandoned crossing. No noticeable issues to report.11/12/2014 Same as last inspection.5/14/2014 Same as last inspection.10/30/2013 Same as last inspection.5/23/2013 Same as last inspection.10/9/2012 Need to determine type of abandonment. FIELD_STRUCT_DESC: *ABANDONED* 10-inch steel drainage pipe through the levee, 4 feet below the crown. Siphon breaker in 36-inch corrugated metal pipe (CMP) riser on the waterside (WS) shoulder. Flap gate on the WS end. (Permit No. 3165, 1959 - State of California Department of Water Resources [DWR]) [Additional Reference(s): DWR Levee Log, 2005]. FS Date: 4/13/2017 2:51:29 PM

36-inch CMP riser on WS shoulder.
